TROUBLESHOOTING for CK2555 & CK2575

AIR TRAP

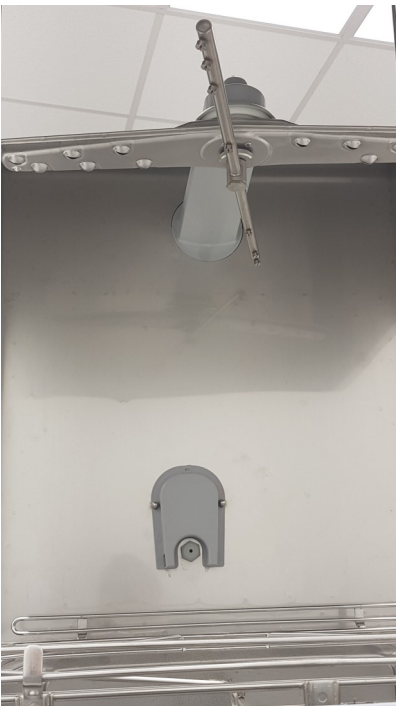
Pic 1

The air trap is located on the back wall inside the washing chamber (Pic 1). A build up of dirt behind the plastic protection means the machine will stop filling. (Pic 2)
